WELLS FARGO MOTOR BANK

FAN RETROFIT

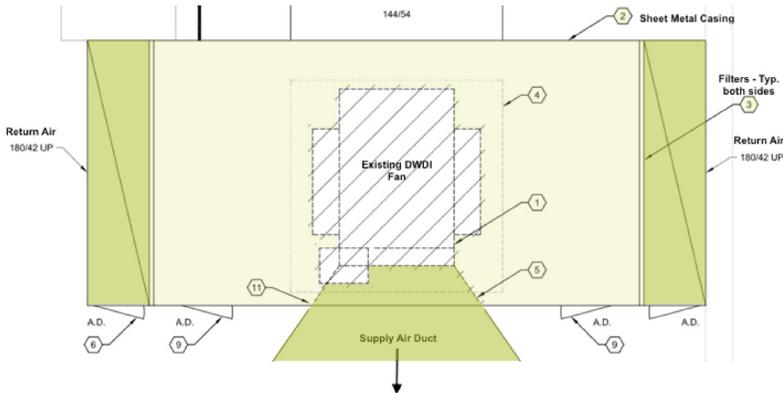
Fig. 1

The existing fan was located within a sheet metal casing with filter banks on each side of fan and supply duct discharging through the side of the casing (Fig. 1).

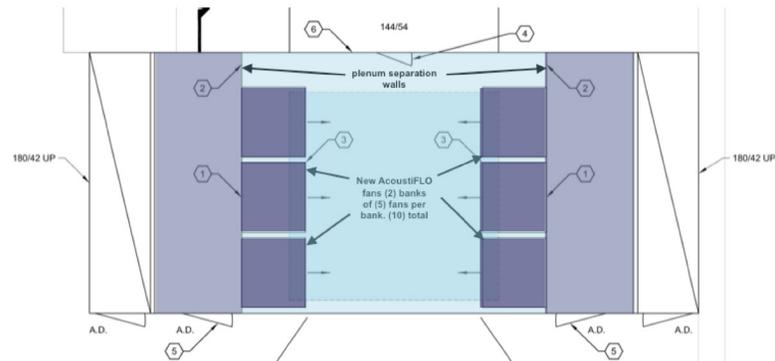
Fig. 2

The new modular fans were installed in arrays on either side of the existing fan over two weekends (Fig 2). During the interim two week period, airflow from the filters flowed around and through the new fan array into the old fan. After completion of the arrays, and final electrical connections to the new fans, the old fan was cut into pieces and removed through the rear of the casing. Plenum walls were installed and sealed and the new fans started.

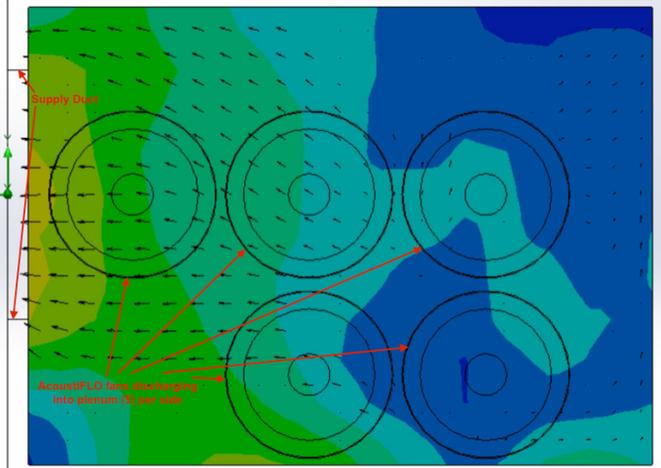
Fig. 3

To confirm aerodynamic performance, AcoustiFLO created a graphic CFD analysis of the resultant flow in the plenum with (10) fans discharging into the plenum (Fig.3).

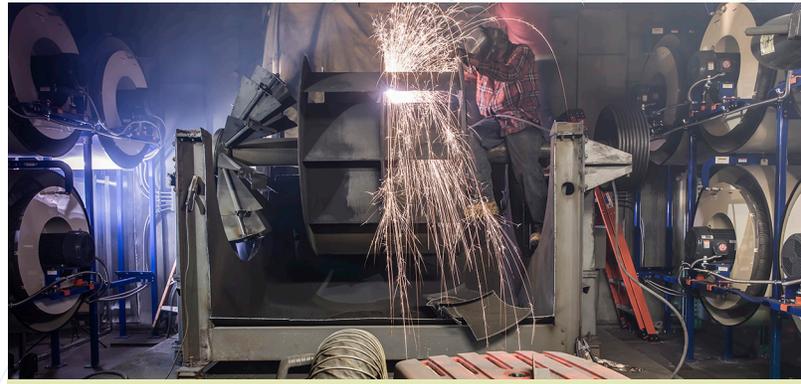
Old Fan Removal

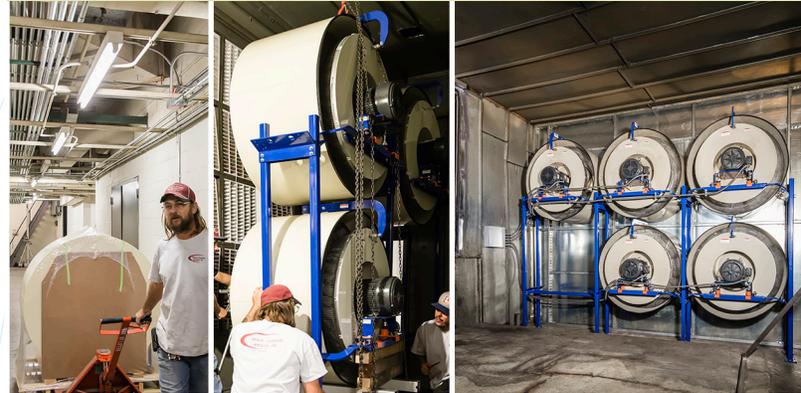
AcoustiFLO Fan Installation

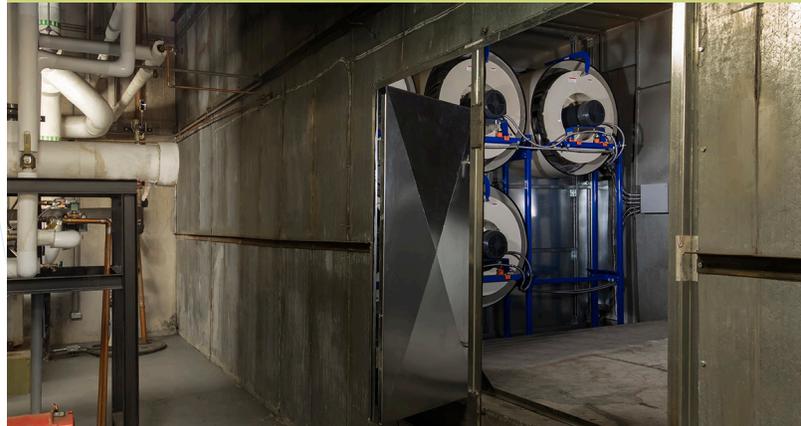
AcoustiFLO Fan Installed
